MAINTENANCE INFORMATION

MI17-22

| SUBJECT: YEARLY INSPECTION OF FUEL TANK CRADLE MOUNTING SCREWS | | | |

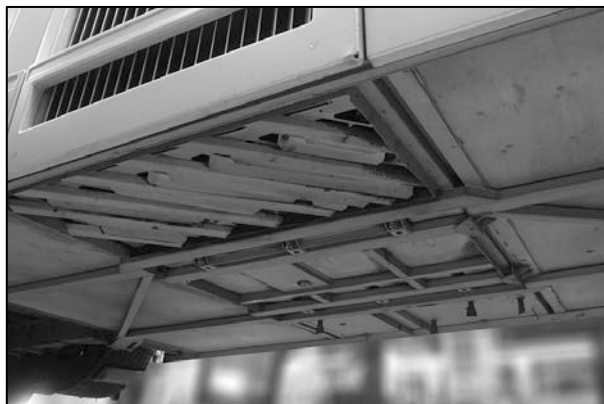
Figure 1: Fuel tank cradle location under vehicle

1. Raise vehicle with safe lifting equipment and procedures.

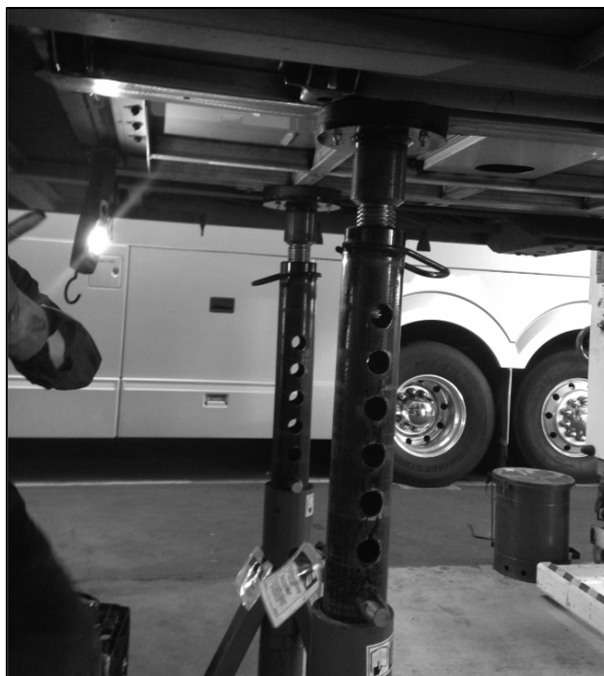
Figure 2: Jack Stands

2. Place jack stands under the fuel tank cradle.

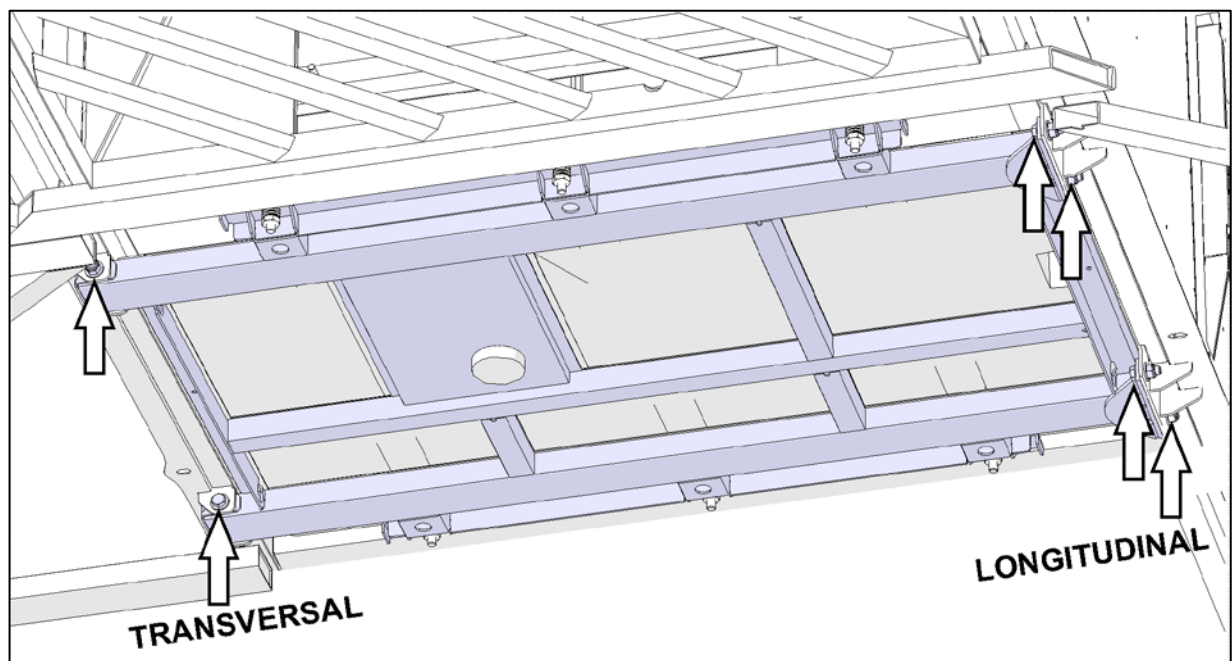
Figure 3 : Location of Mounting Points

3. Locate the mounting points of the fuel tank cradle under the vehicle frame (Figure 3)
4. Carefully inspect fuel cradle mounting bolts, 6 locations.(Figure 3)
5. Replace any bolt showing signs of wear by new hardware.

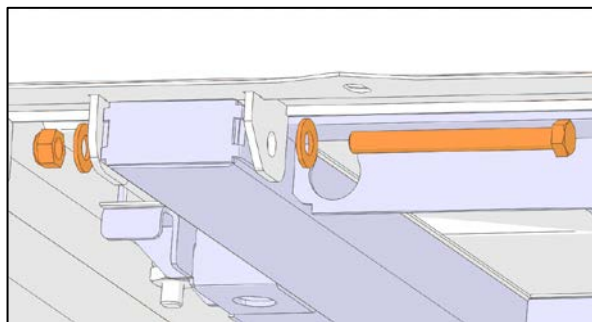
Figure 4 : Transverse Screws, 2 locations

6. On the transversal screw joints, (Figure 4) any visible gap between cradle support tubing and vehicle frame mounting lugs is not acceptable. It could indicate safety recall [SR17-28](#) has not been performed on the vehicle.

If it is indeed the case, perform safety recall [SR17-28](#) in priority over this maintenance inspection.

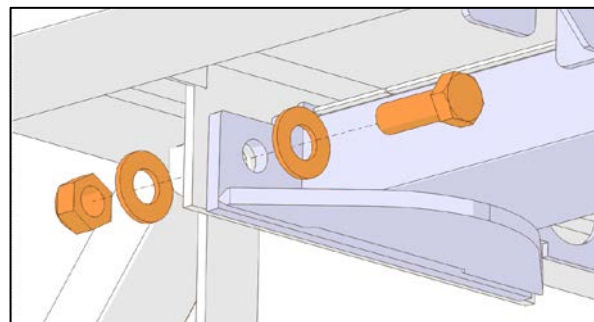
Figure 5 : Longitudinal Screws, 4 locations

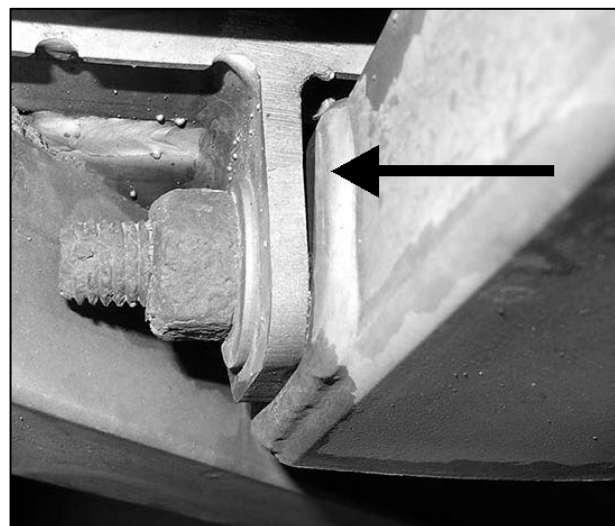
Figure 6 : Visible gap on transversal screw joint

7. If shims are not present, the visible gap should be shimmed using parts 030082 and 030083 as required.
8. Shim arrangement may vary and may be stacked on both sides.

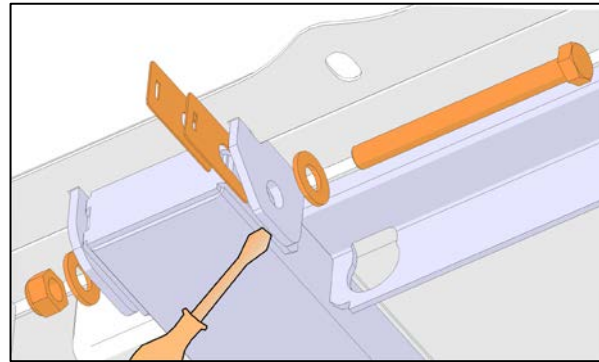
Figure 7 : Shim installation, transverse screw. Arrangement may vary.

9. Tighten to **82 lb-ft**.
10. Apply torque seal mark.
